Impacts and causative fault of the 2022 magnitude (M_w) 7.0 Northwestern Luzon earthquake, Philippines

Department of Science and Technology—Philippine Institute of Volcanology and Seismology (DOST-PHIVOLCS), Quezon City, Philippines

At 00:43 UTC on 27 July 2022, a 15-km deep major earthquake with magnitude (M_w) 7.0 struck Northwestern Luzon, Philippines. The strongest ground shaking felt was at PHIVOLCS Earthquake Intensity Scale (PEIS) VII (destructive), equivalent to Modified Mercalli Intensity (MMI) VII, in Abra and along the coastal areas of Ilocos Sur. More than a thousand landslides, rockfalls and tension cracks were mapped, near the epicentral region, in the northwestern part of the Central Cordillera. Most of the landslides were shallow-seated, many of which were situated along road cuts. Liquefaction manifested as lateral spreads, sand boils, fissures, ground subsidence, and localized swelling was documented along the coastal areas of Ilocos Sur and river channels in Abra and Ilocos Sur. Sea level disturbance was also observed in some coastal areas of Ilocos Sur and La Union. Damages to buildings and infrastructures were documented in areas that experienced PEIS VI (ver

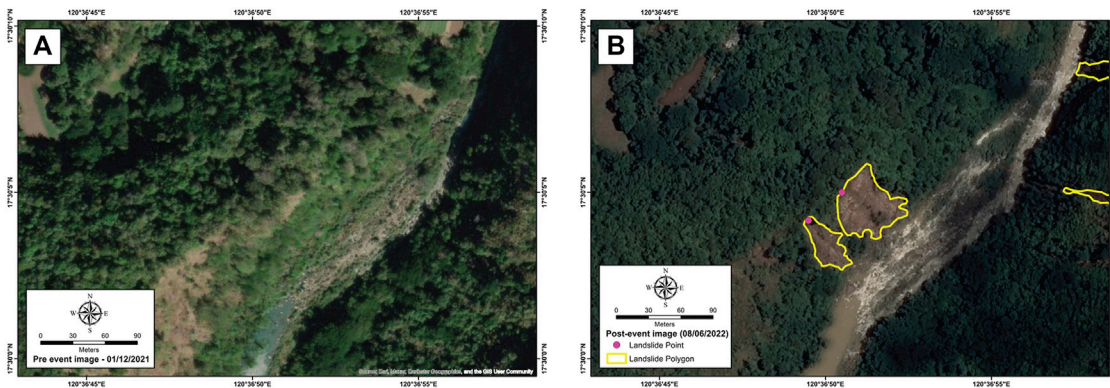
FIGURE 6 Comparison of remote sensing images for landslide identification. **(A)** Pre-event satellite image taken on 12 January 2021 (Source: Esri, Maxar, Earthstar Geographics and the GIS User Community); **(B)** Landslides (yellow polygon) identified using post-event satellite image taken on 06 August 2022 (Source: Pleiades 1B). Refer to [Figure 5](#) for the location of the landslide.

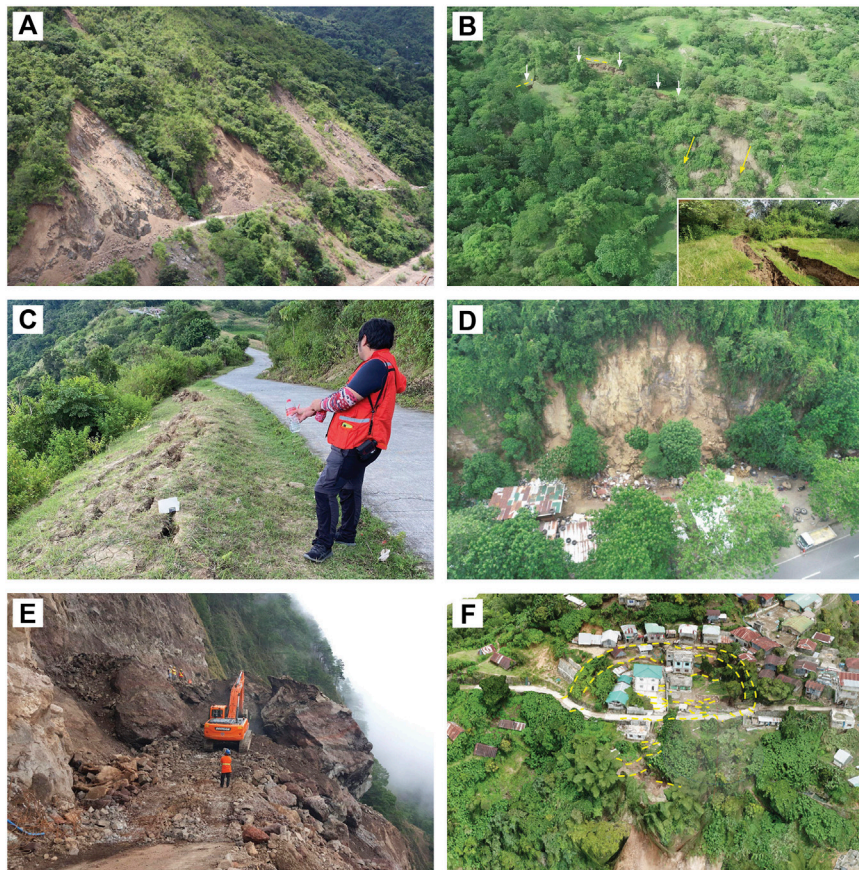
FIGURE 7

Documented landslides after the 2022 Mw 7.0 Northwestern Luzon Earthquake. **(A)** Aerial photo of series of roadcut landslides which caused road blockages in Luba, Abra; **(B)** Drone imagery of the tension cracks (white arrow) and landslides (yellow arrows) in Dolores, Abra; **(C)** Series of tension cracks traverse the ridge crest in along the boundaries of San Isidro, Abra and Nagbukel, Ilocos Sur; **(D)** Aerial photo of the observed rockslide on a steep slope adjacent to several residential houses Bangued, Abra; **(E)** Massive rockslide along the Benguet-Mt. Province National Road in Bauko, Mt. Province. **(F)** Aerial photo of the deep-seated rotational slide with landslide crown near residential houses associated with a series of tension cracks and roadslip progressing downslope in Sadanga, Mt. Province. Refer to [Figure 5](#) for the location of the photographs.

These landslides were manifested as shallow-translational slides, rockslides, and some deep-rotational slides which caused damage to buildings and infrastructures, road blockage, isolation of communities,

temporary community evacuation, and casualties. Translational slides and rockslides commonly occurred adjacent to road cuts that lacked proper slope protection and reinforcement ([Figure 7A](#)). Tension cracks and deep-rotational slides, in contrast, were documented more commonly on hillslopes ([Figure 7B](#)). Some notable earthquake-induced landslides observed are extensive tension cracks with some failures observed near the boundaries of San Isidro, Abra and Nagbukel, Ilocos Sur ([Figure 7C](#)); rockslides near the residential houses in Bangued, Abra ([Figure 7D](#)) that resulted to the immediate evacuation of the community; road blockage caused by rockslides and landslides, an example is a massive rockslide in Bauko, Mountain Province ([Figure 7E](#)); and a deep-seated rotational landslide with identified landslide crown associated with a series of tension cracks and road displacement in Sadanga, Mountain Province ([Figure 7F](#)). Areas with landslides were assigned to PEIS VI (very strong) and PEIS VII (destructive) ([Figures 4, 5](#)).

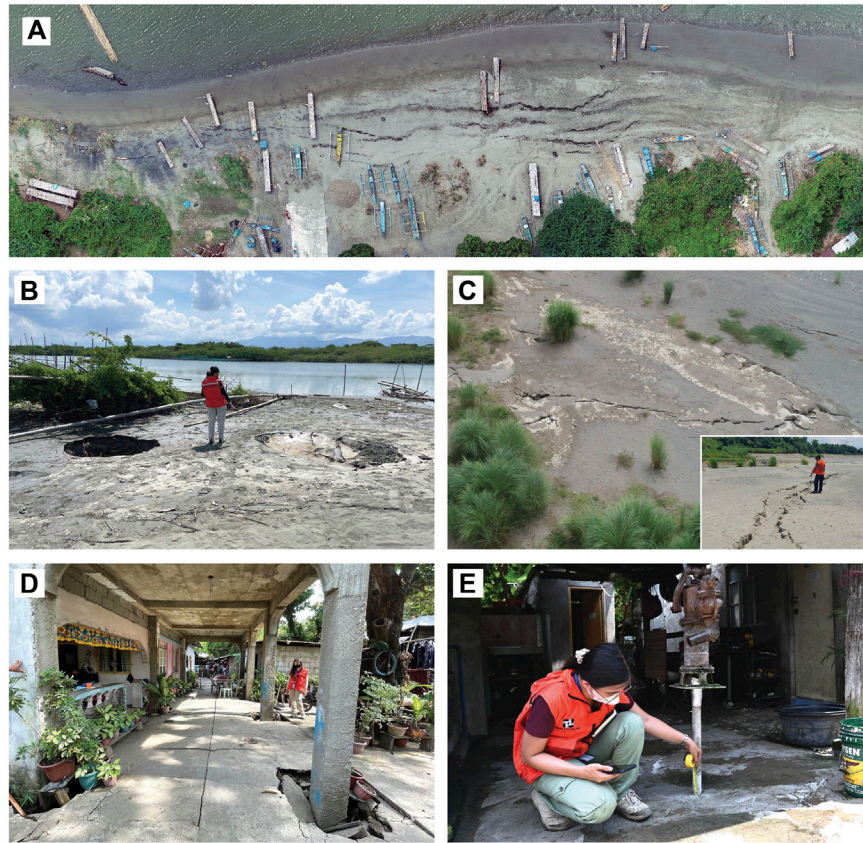
FIGURE 8

Documented liquefaction after the 2022 Mw 7.0 Northwestern Luzon Earthquake. (A) An orthophoto (derived using remotely piloted aircraft) of lateral spreads along the coast of Santa, Ilocos Sur which extends to approximately 300 m; (B) Numerous sand boils on the coast of San Vicente in Ilocos Sur; (C) Ground fissures along a point bar of the Abra River in Tayum, Abra; (D) Building settlement of approximately 45 cm on a delta in Caoayan, Ilocos Sur; (E) Raised artesian well with 10 cm displacement in Santa Cruz, Ilocos Sur. Refer to Figure 5 for the location of the photographs.

sediments and shallow groundwater (MGB, 2008) (Figure 5, Figures 8A–E). Some of the liquefaction impacts appeared along the flood plains, tributaries and point bars of the Abra River, which meanders through the western portion of Abra and drains towards its delta located west of Ilocos Sur. Liquefaction was also documented on beaches, fills, marshes, and other river banks facing the West Philippine Sea and as far as 110 km southwest from the epicenter.

liquefaction also caused damage to built-up areas. Differential settlement of buildings (Figure 8D) and uplift of buoyant structures (Figure 8E) were also documented. While liquefaction affected some large swaths of land, there were few documented structural damages since most of the liquefaction impacts occurred far from communities and developed areas. Areas with manifestations of liquefaction were assigned to PEIS VII (destructive) and most of these are located south of the epicenter (Figures 4, 5).

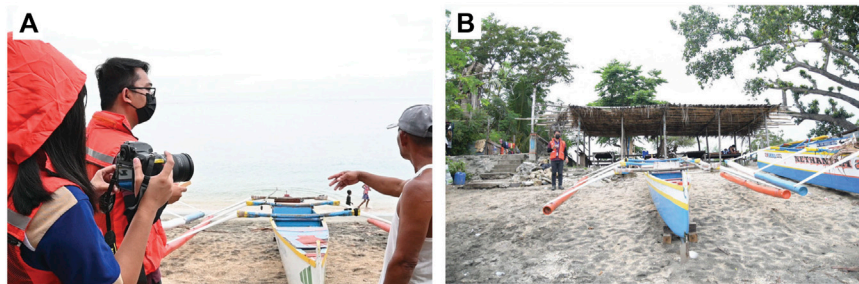
FIGURE 9

Documented sea level disturbance after the 2022 Mw 7.0 Northwestern Luzon Earthquake. (A) Interviews were conducted in the field to verify the reports of sea level disturbance after the earthquake. Interviewees reported a 2-m-high wave in Luna, La Union; (B) onshore extent (person standing) of displaced boats docked along the coast. Refer to Figure 5 for the location of sites with reports of sea level disturbance.

Sea level disturbance was observed in coastal areas of Ilocos Sur and La Union (Figure 5 and Supplementary Table S1). In Ilocos Sur, based on the DOST-PHIVOLCS QRT interview, residents reported a sudden drop in the sea level, which returned to normal a few seconds to minutes after the shaking. Despite the distance from the epicenter (~80 km away), 2 m high waves were noted in Luna, La Union, which displaced several boats docked along the coast (Figure 9). The observed sea level disturbance can be attributed to submarine landslides triggered by the earthquake and/or water oscillation generated by strong shaking. Detailed studies are ongoing such as bathymetric mapping and tsunami modeling and simulation to better explain this phenomenon.

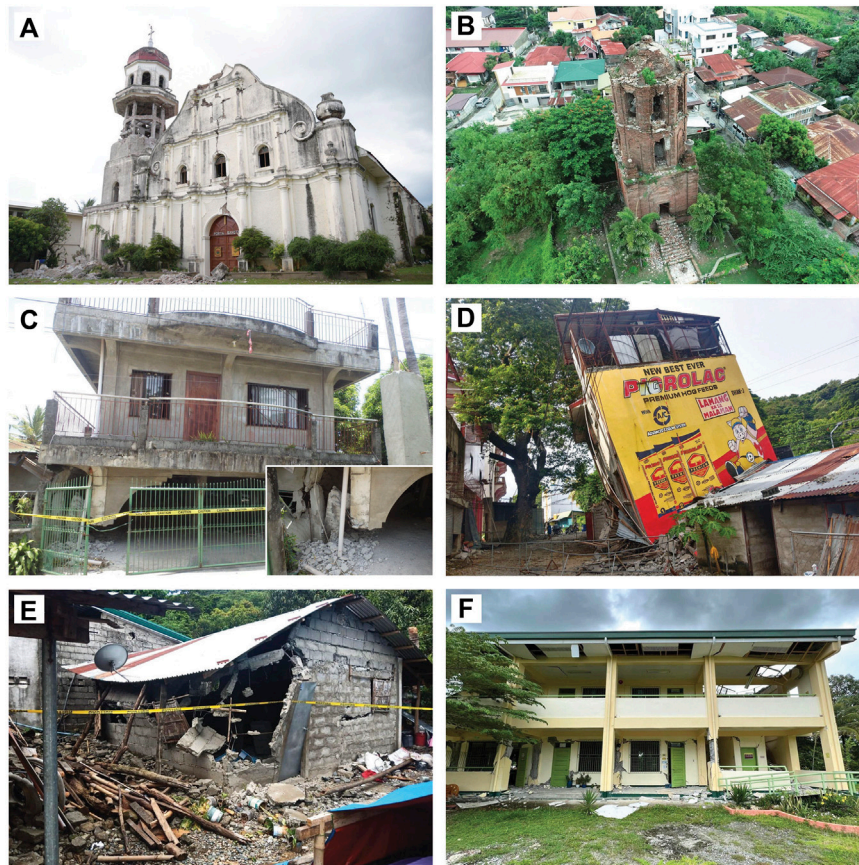
FIGURE 10

The DOST-PHIVOLCS QRT conducted an assessment of selected damaged structures in Abra and Ilocos Sur (Figure 5 and Figure 10A–E). Most of the surveyed buildings in Ilocos Sur are historical buildings (more than 100 years old) and were classified as unreinforced structures while in Abra, old and newly constructed structures, classified as unreinforced, reinforced and concrete hollow block (CHB) structures were assessed. In Abra, the 19th-century baroque church, Santa Catalina Alexandria Church or Tayum Church (Figure 10A), was totally damaged showing widespread large vertical, diagonal, and crisscrossing cracks in the masonry walls and its façade. The displaced large masonry wedge inside the church suggests that the structural support has been compromised.

Spalling of concrete on the strengthened bell tower was also observed. The St. Augustine Church belfry built in 1591 (also known as the Bantay Bell Tower), in Ilocos Sur, experienced spalling on its façade and large cracks along the tower (Figure 10B).

It was documented by the DOST-PHIVOLCS QRT that different reinforced concrete and CHB buildings in Abra suffered different types of damages. Because of substandard columns, some multi-story residential and commercial buildings suffered pancake-type collapse (Figure 10C). Poor construction practices and substandard building design resulted in the tilting of a three-story commercial building in Abra (Figure 10D). Most of the residential houses in Abra are made up of CHB and non-engineered. Poor qualities of the CHB and steel bars have resulted in the collapse of walls and gable walls (Figure 10E). Even newly constructed multi-story, reinforced concrete buildings, some of which are government buildings, such as schools have suffered significant damages which resulted in the abandonment of these buildings (Figure 10F). Poor construction, improper building designs and substandard construction materials subjected to intense ground shaking resulted to severe damages to these reinforced concrete and CHB buildings. The buckling of roads in different areas was also documented.

Damaged structures after the 2022 Mw 7.0 Northwestern Luzon Earthquake. (A) Totally damaged 19th-century baroque church, the Santa Catalina Alexandria Church, in Tayum, Abra; (B) Damaged 16th-century belfry of the St. Augustine Church (Bantay Bell Tower); (C) Pancake-type collapse of a two-story residential building; (D) Tilted three-story commercial building; (E) Completely damaged concrete hollow block residential house; (F) Completely damaged two-story school building. Refer to [Figure 5](#) for the location of the photographs.
