Impacts and causative fault of the 2022 magnitude (M_w) 7.0 Northwestern Luzon earthquake, Philippines

Department of Science and Technology—Philippine Institute of Volcanology and Seismology (DOST-PHIVOLCS), Quezon City, Philippines

At 00:43 UTC on 27 July 2022, a 15-km deep major earthquake with magnitude (M_w) 7.0 struck Northwestern Luzon, Philippines. The strongest ground shaking felt was at PHIVOLCS Earthquake Intensity Scale (PEIS) VII (destructive), equivalent to Modified Mercalli Intensity (MMI) VII, in Abra and along the coastal areas of Ilocos Sur. More than a thousand landslides, rockfalls and tension cracks were mapped, near the epicentral region, in the northwestern part of the Central Cordillera. Most of the landslides were shallow-seated, many of which were situated along road cuts. Liquefaction manifested as lateral spreads, sand boils, fissures, ground subsidence, and localized swelling was documented along the coastal areas of Ilocos Sur and river channels in Abra and Ilocos Sur. Sea level disturbance was also observed in some coastal areas of Ilocos Sur and La Union. Damages to buildings and infrastructures were documented in areas that experienced PEIS VI (ver

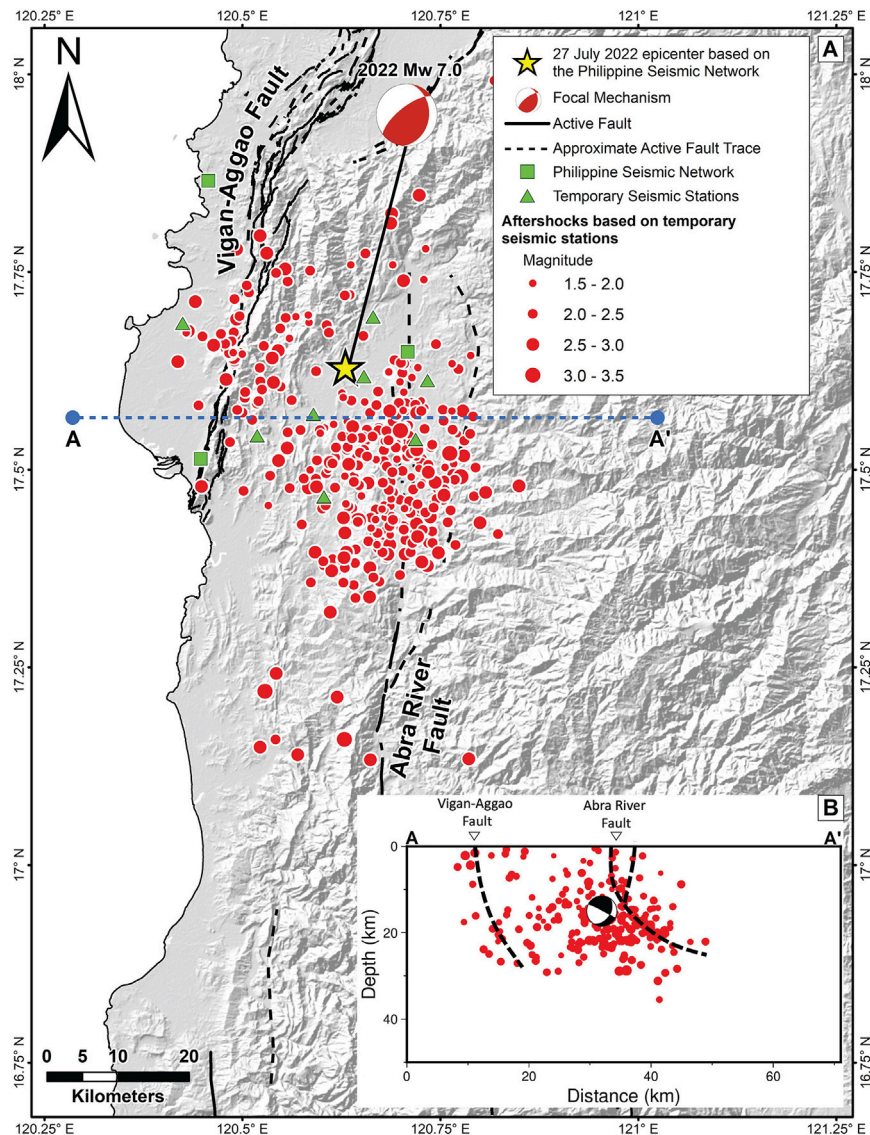
FIGURE 2

Aftershocks after the 27 July Mw 7.0 Northwestern Luzon Earthquake. (A) Aftershock distribution from 28 to 30 July 2022 was recorded by the temporary seismic stations installed around the epicentral region. (B) East-west cross-section of the aftershock distribution. From the spatial distribution of aftershocks, we can observe two clusters of aftershocks, first along the Abra River Fault and second, along the southern portion of the Vigan-Aggao Fault.

To augment the PSN and to constrain the spatial distribution of the aftershocks of the 2022 Northwestern Luzon Earthquake, eight additional temporary seismic stations were installed by the DOST-PHIVOLCS QRT around the epicentral region. Figure 2A shows the aftershock distribution for 3 days (28–30 July 2022) while Figure 2B is an east-west cross-section. The aftershock distribution appears to have a northerly trend and favors a N-S striking fault plane that is gently dipping to the east consistent with the derived focal mechanism (Section 3.2; Figure 1A, Figure 3). We can also observe two clusters of aftershocks, most of the aftershocks were located along the Abra River Fault while the second cluster was along the southern portion of the Vigan-Aggao Fault (Figure 2).

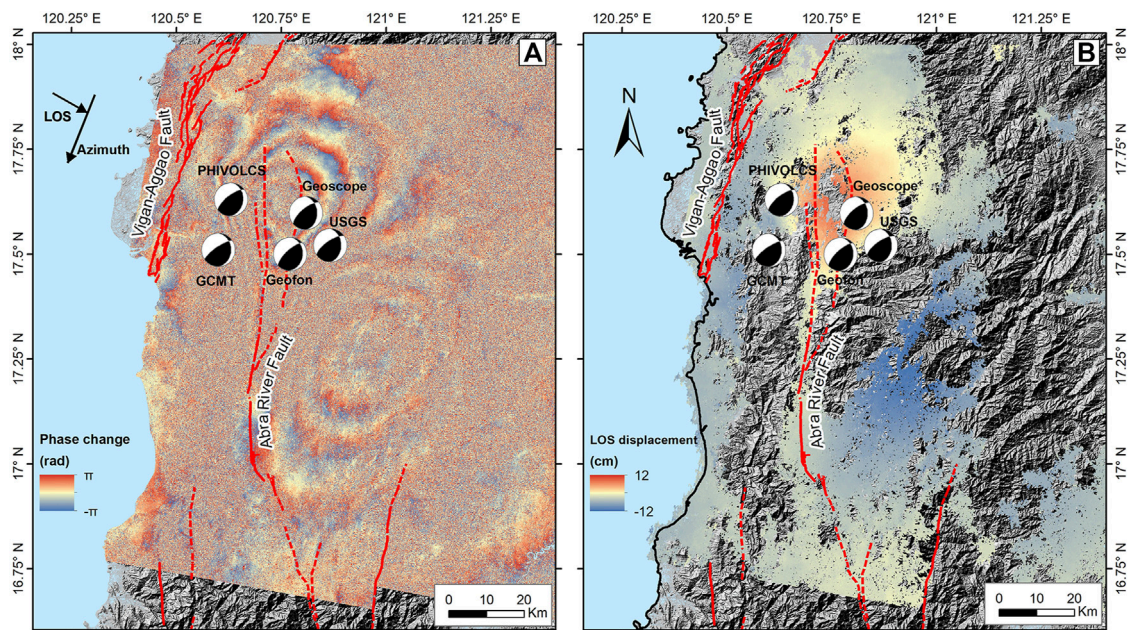
FIGURE 3

Coseismic deformation observed from InSAR using Sentinel-1 images (06/27/2022 and 08/02/2022) descending track. (A) Interferogram shows coseismic deformation concentrated at the eastern side of the Abra River Fault; one cycle of fringes is equivalent to 2.8 cm. (B) Unwrapped LOS displacement field indicates movement toward the satellite (red areas) on the northern portion, while movement away from the satellite (blue areas) on the southern portion. Areas with low coherence were masked. Focal mechanism solutions were from DOST-PHIVOLCS, USGS, GCMT, Geofon and Geoscope.

Despite the fact that many areas display low coherence probably due to dense vegetation, the coseismic interferogram (Figure 3A) reveals clear concentrations of interferometric fringes that seem to form a north-south deformation pattern. The northern fringes indicate movement toward the satellite while the southern fringes suggest a movement away from the satellite. Peak displacements reach 14 cm in the radar line-of-sight (LOS) direction, based on the displacements derived from the unwrapped interferogram (Figure 3B). A primary surface rupture, however, was not evident in the interferograms. Moreover, the deformation is mostly concentrated on the eastern block of the Abra River Fault. This is similar to the deformation pattern of faults with significant reverse motion in which deformation generally appears on the hanging wall (Donahue and Abrahamson, 2014; Abrahamson and Silva, 1997; Chang et al., 2005; Su et al., 2019).

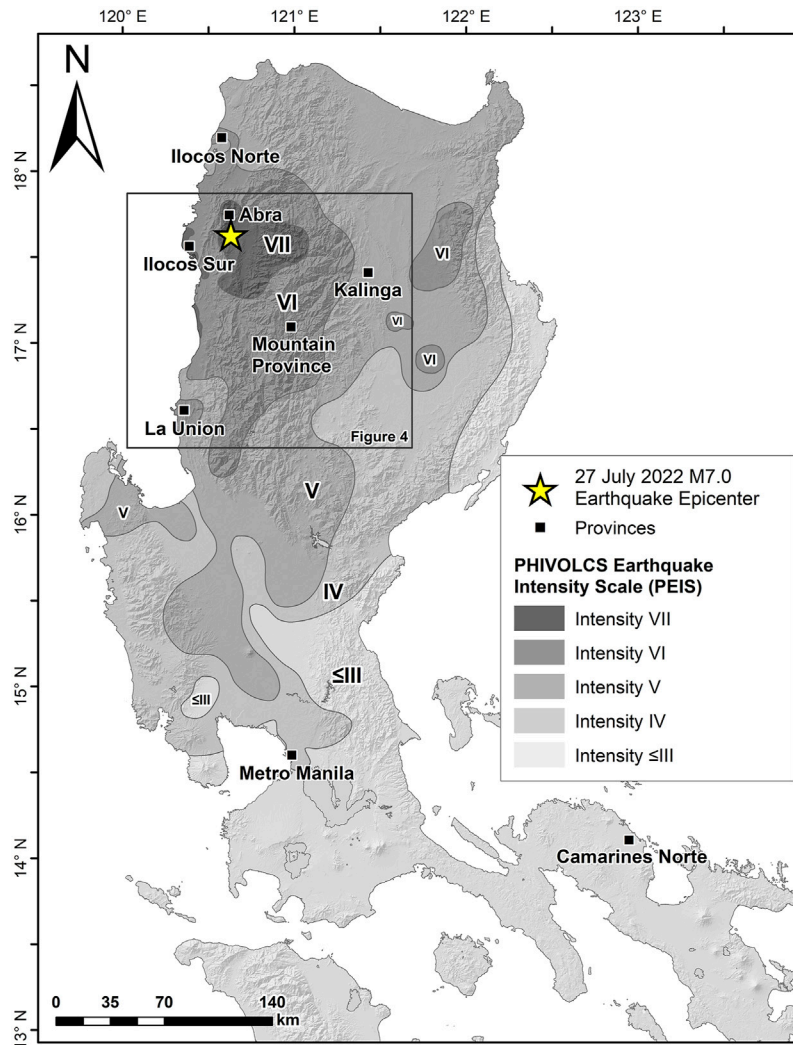
The maximum earthquake intensity for this event was PEIS VII (destructive) equivalent to MMI VII and was felt mostly in Abra and the coastal areas of Ilocos Sur (Figure 4). The maximum intensity was felt for about 2,200 sq. km. Areas with PEIS VII (destructive) suffered significant damage to old and poorly built structures while some well-built structures, mostly residential houses, are slightly damaged. Based on interviews by the DOST-PHIVOLCS QRT, people in these areas were frightened and some ran outdoors. Liquefaction, landslides and sea level disturbance were also documented in these areas (Figures 5–9). The rest of Ilocos Sur, parts of Ilocos Norte, La Union, Mountain Province and Kalinga felt the earthquake at PEIS VI (very strong) equivalent to MMI VI. People in these areas were frightened and some ran outdoors. They observed cracks in wall plaster and significant

FIGURE 4
 The 27 July M7.0 Northwestern Luzon Earthquake Isoseismal Map. The isoseismal map was based on the latest earthquake information (PHIVOLCS, 2022c) and the result of the DOST-PHIVOLCS QRT field investigation and impact assessment. The intensities used for the isoseismal map are based on the PHIVOLCS Earthquake Intensity Scale (PEIS) (PHIVOLCS, 2022d). The rectangle shows the location of Figure 5.

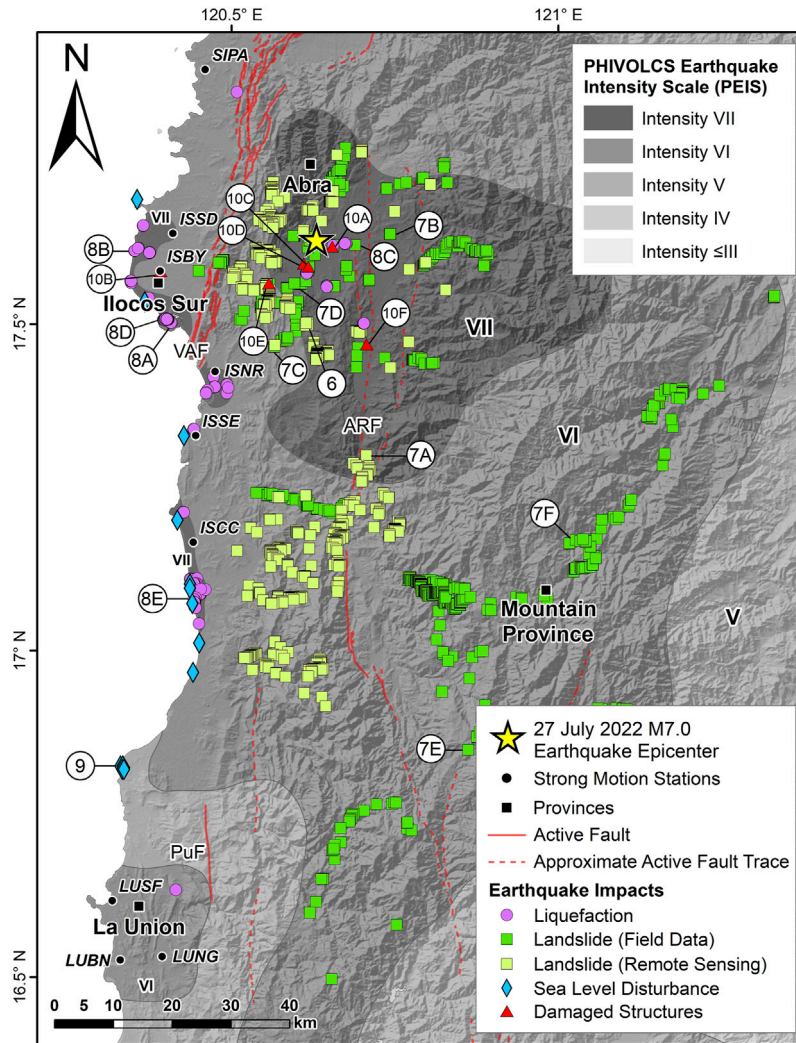
FIGURE 5 Impact Map of the 2022 M7.0 Northwestern Luzon Earthquake. Spatial distribution of documented geologic impacts, (earthquake-induced landslides, liquefaction and sea level disturbance) during the 2022 Mw 7.0 Northwestern Luzon Earthquake. Black circles show the location of the accelerographs with station code from the Philippine Strong Motion Network (PSMNet). Circles with letters and numbers show the location of photos in [Figures 6–10](#). PuF—Pugo Fault, VAF—Vigan-Agcao Fault (also known as West Ilocos Fault System), ARF—Abra River Fault.

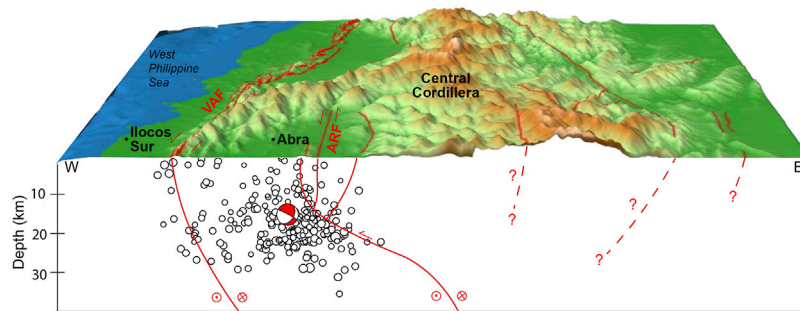
FIGURE 11

The spatial distribution of the geologic impacts may also reveal the characteristics of the causative fault. Earthquake-induced landslides are usually concentrated near the causative fault, hence their spatial distribution is generally controlled by the fault. Most of the landslides triggered by this earthquake occurred within 20 km from both sides of the causative fault, which further supports the interpretation that the Abra River Fault is the probable causative fault. Commonly, more landslides occurred on the hanging wall as compared to the footwall called the hanging wall effect (Abrahamson and Silva, 1997; Chang et al., 2005; Donahue and Abrahamson, 2014; Xu et al., 2014). However, for this earthquake, the landslides on the footwall were more than that on the hanging wall. This can be attributed to two factors. The difference in the geology of the opposite sides of the Abra River Fault may have contributed to the spatial distribution of earthquake-induced landslides (Gorum, 2013). The hanging wall is composed of metamorphosed basement rocks and a series of intrusive and extrusive igneous rocks while the footwall is overlain by shallow to deep marine

Schematic diagram of the causative fault of the 2022 Mw 7.0 Northwestern Luzon Earthquake. Sub-surface representation of the Abra River Fault (ARF), Vigan-Aggao Fault (VAF) (also known as West Ilocos Fault System) and other faults in the region based on focal mechanism solution and clustering of aftershocks. The causative fault, which has a gentle dip and oblique-slip is a part of the positive flower structures at a depth that connects to the surface trace of the Abra River Fault. Open black circles are aftershocks after the 2022 Mw 7.0 Northwestern Luzon Earthquake (Section 3.1). The focal mechanism solution is from DOST-PHIVOLCS SWIFT-CMT Solution (Section 3.2). Red lines are traces of active faults.
